Manhole Inspection Summary

Manhole # S35UU_001MH

Insp Date: 1/11/07 11:31 AM

Location Address: **347 29TH ST**

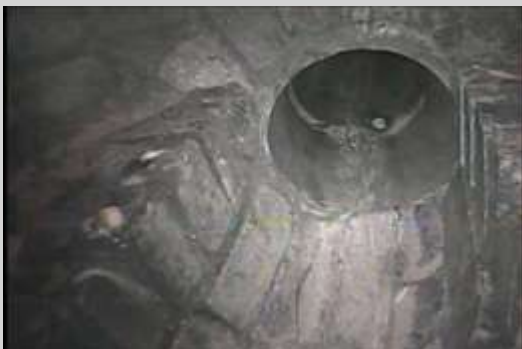
10 in. Circular Gravity Sewer Pipe In @ 3 O'Clock

Pipe Material: **Clay** ☐ Pipe Lined

Invert Depth: **11.72** (ft.) Flow Characteristics: **Slow**

Deposits: ☒ None ☐ Mud ☐ Sludge ☐ Debris ☐ Grease

Infiltration: **None** Pipe Seal Cond: **Unknown**

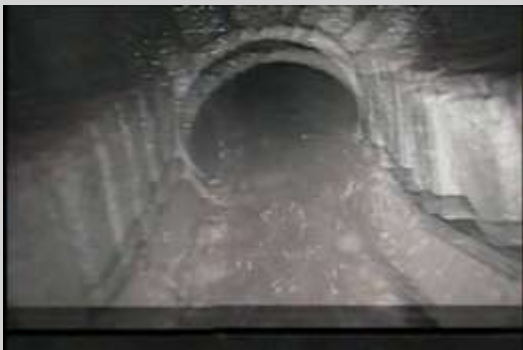
8 in. Circular Gravity Sewer

Pipe Material: **Clay** ☐ Pipe Lined

Infiltration: **None** Pipe Seal Cond: **Unknown**
